SPECIAL PUBLICATION 116

THE NORTHRIDGE, CALIFORNIA, EARTHQUAKE OF 17 JANUARY 1994

DIVISION OF
MINES AND GEOLOGY

**The Northridge, California, Earthquake
of 17 January 1994**

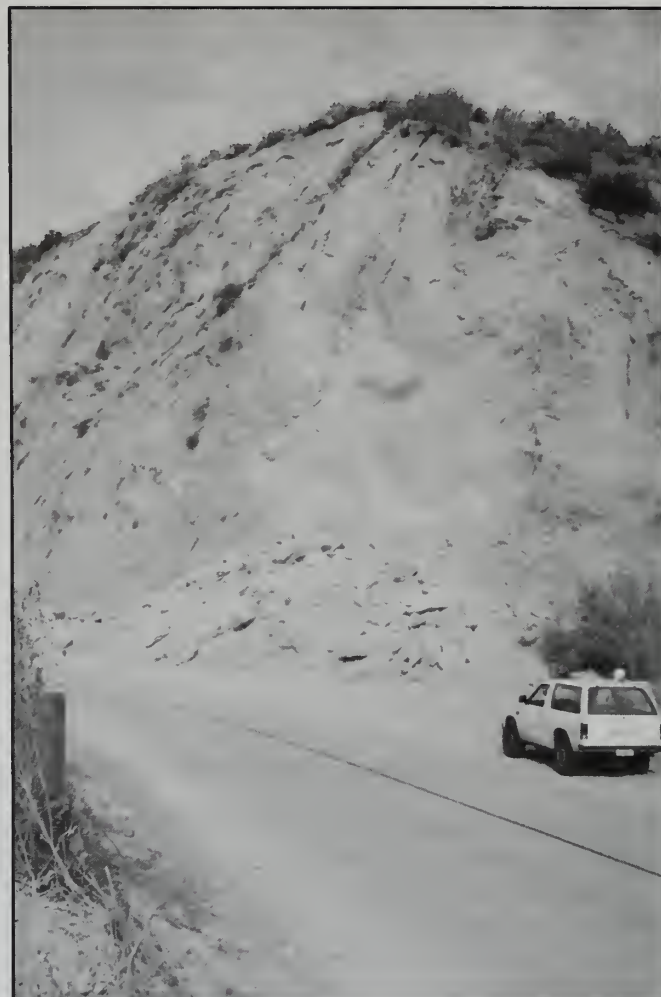
Photo 1. Rockfall from massive sandstone beds in marine Pico Formation along Pico Canyon Road. Photo by S.S. Tan, 1/22/94.

The susceptibility to rockfalls, specifically along the cliffs of Pico Formation that form the north wall of Pico Canyon, was emphasized by Treiman (1986, Plate 2A2). Indeed, steep to vertical cliffs in sandstone and conglomerate beds of the Pico Formation were the source of numerous large rockfalls (Photo 1).

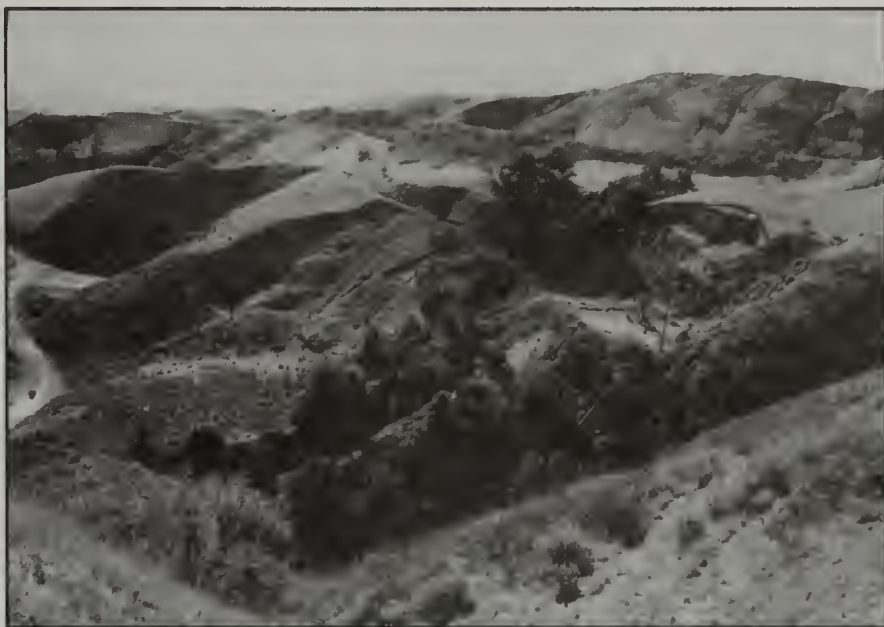
the vicinity of Mission Point (Barrows and others, 1975b, Plate 2; Saul, 1979, Plate 1). During the earthquake, portions of many pre-existing landslides were reactivated and several new slumps developed, as well, on the slopes above Granada Hills. In the Aliso Canyon Oil Field on Oat Mountain (Photo 2) landslides damaged oil facilities and fill settlement disrupted access roads (Figure 1, locality 4).

Photo 2. View south from top of Oat Mountain toward oil well in Aliso Canyon Oil Field sitting on cut pad in older landslide. To right of oil well are fresh headscarps and curved cracks from Northridge earthquake-triggered enlargement of pre-existing landslide. Photo by S.S. Tan, 1/26/94.

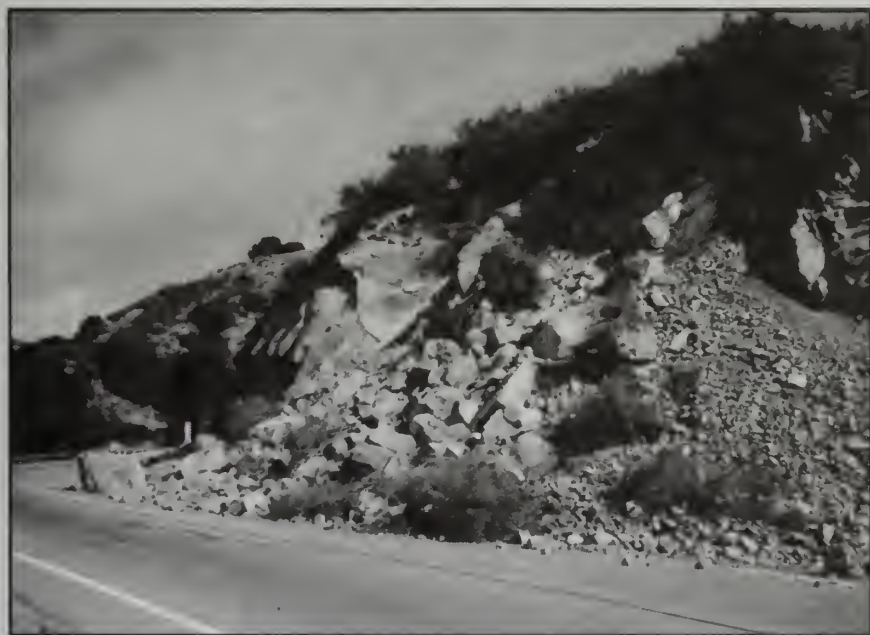
Santa Susana Pass Road was closed where it enters the southeastern corner of Simi Valley due to numerous rock-falls, primarily from north-facing roadcuts (Photo 3) in blocky and jointed, Cretaceous marine sandstone of the Chatsworth Formation (Figure 1, locality 5).

Photo 3. Rockfall onto Santa Susana Pass Road just west of the pass from north-facing roadcut in massive sandstone of the Cretaceous Chatsworth Formation. Photo by P.J. Irvine, 1/19/94.

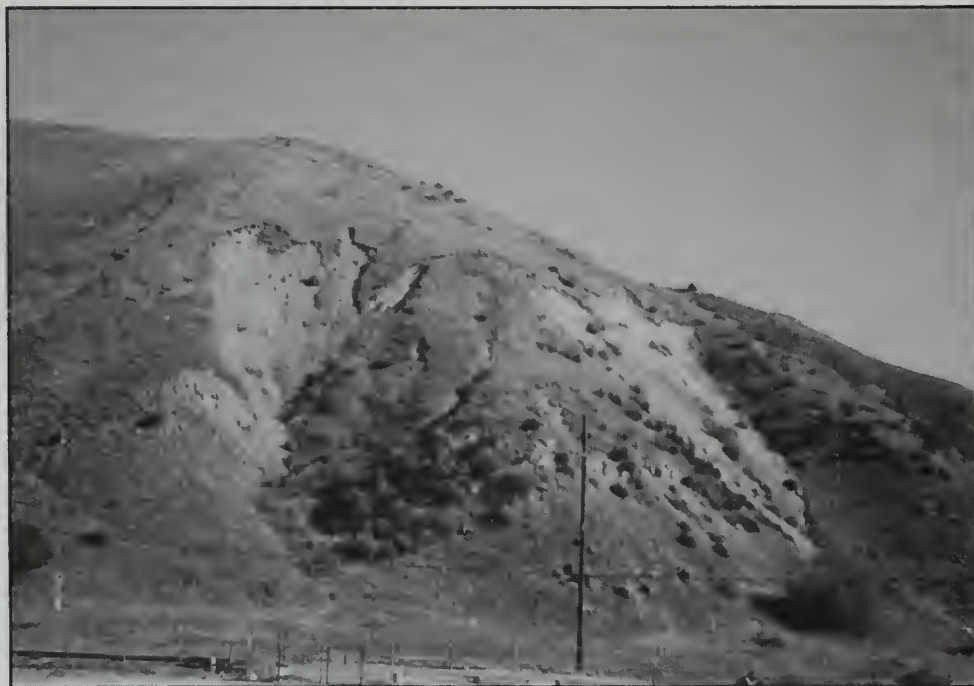
Photo 4. Very shallow soil falls and debris slides on south-facing slopes in Modelo Formation sandstone at the mouth of Lopez Canyon. The trace of the Tujunga Segment of the San Fernando Fault Zone lies at the base of the slope on the right. Photo by A.G. Barrows, 1/18/94.

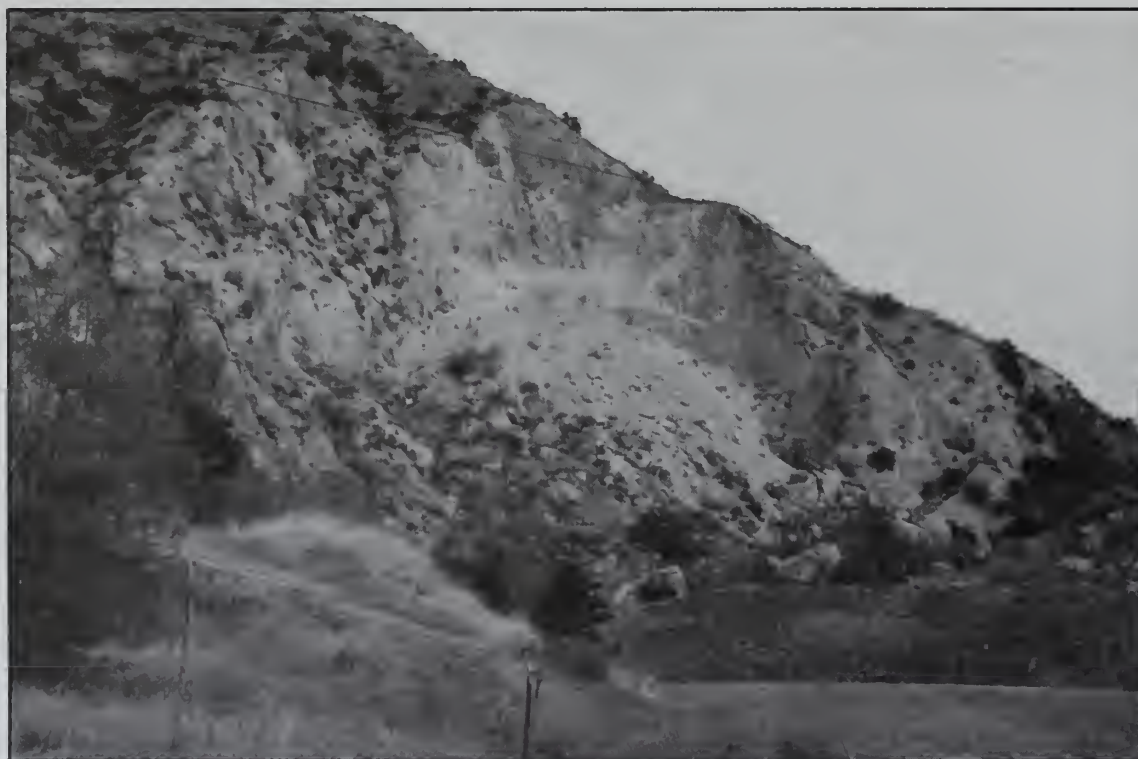
Photo 5. Rockfall from west-facing cliff in Pico Formation sandstone at south end of San Fernando Pass. Light-colored debris fell upon rockfall deposit that resulted from larger landslide triggered by 1971 San Fernando earthquake. Photo by S.S. Tan, 1/22/94.

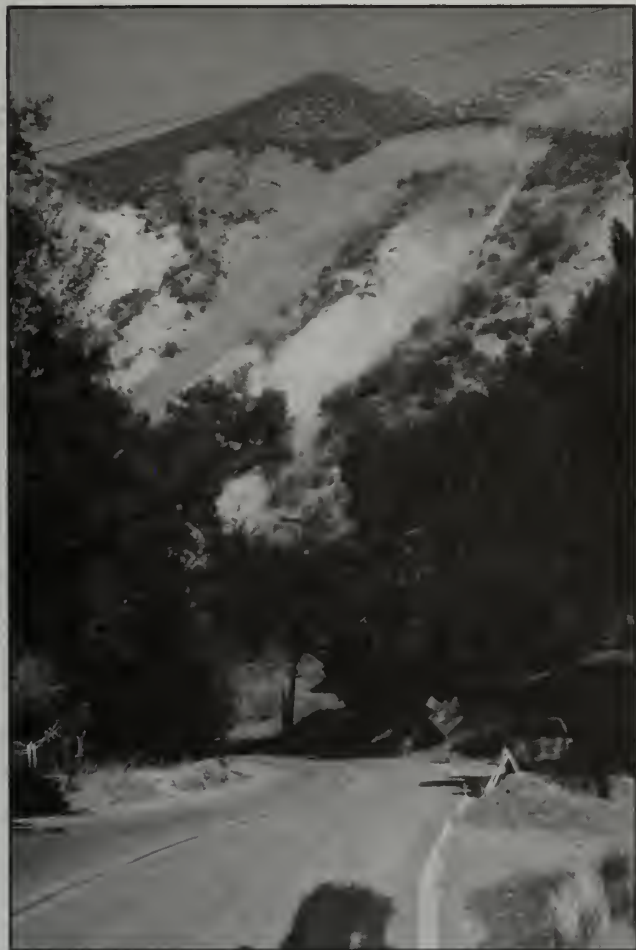
Photo 6. Large rockslides along Little Tujunga Road that originated in shattered granitic and metamorphic rocks directly on trace of San Gabriel Fault one mile (1.6 km) west of Dillon Divide in the San Gabriel Mountains. Photo by A. G. Barrows, 1/20/94.

fault traces is due to a combination of factors. Igneous and metamorphic rocks close to the fault are densely sheared and fractured because of innumerable movements along this fault zone. In addition, reconnaissance of the region traversed by the San Gabriel Fault immediately after the earthquake, led to the observation that surface effects were substantially more abundant southwest of the fault zone than in the region northeast of the trace. Apparently, the fault plane acted as a reflector of seismic energy, which resulted in effects clustering near the fault. Consistent with this assertion is the evidence seen near Bouquet Junction, several miles northwest of Little Tujunga Road, of a concentration of effects close to the trace of the San Gabriel Fault that included ground cracks, aligned with the strike of the fault, with as much as 3 cm of right-lateral displacement. Again, this is not a manifestation of actual "fault movement" but is likely due to focusing of shaking in the vicinity of the fault where it juxtaposes different geologic units with, very likely, contrasting physical properties.

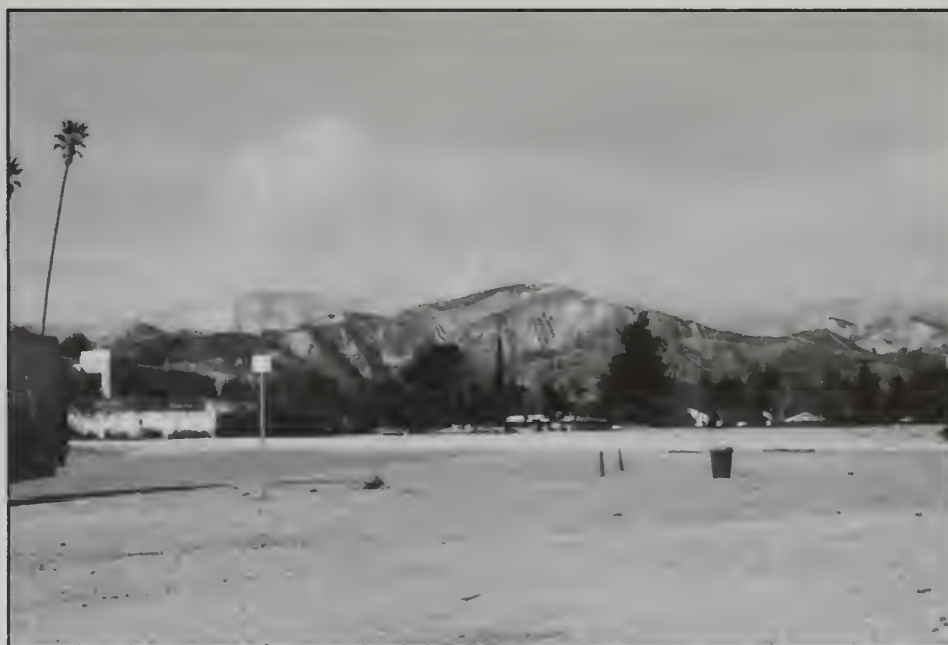
Photo 7. View northward toward the cliffs of "White Face" on Big Mountain from the City of Simi Valley Civic Center. Clouds of dust and rockfalls resulted from a 5.0 magnitude aftershock centered 5 miles east of Simi Valley on January 19, 1994. Photo by P.J. Irvine.

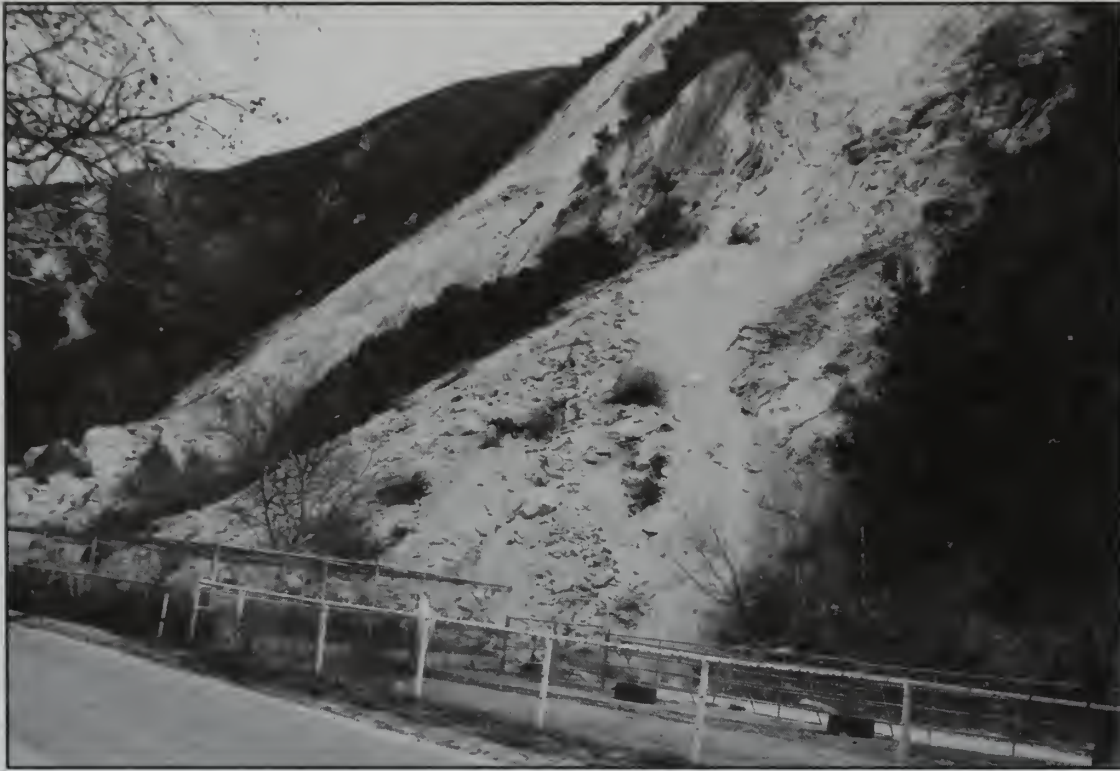
Photo 8. Rockfall from north-facing cliffs in Tapo Canyon, north of Simi Valley. Photo by S.S. Tan 2/1/94.

Not only were rockfalls common on south-facing slopes, such as White Face, but they also developed abundantly along north-facing slopes in the Tapo Canyon-Big Mountain region as well (Photo 8). The location of landslides in this area reflects the strong north-south component to the shaking. Additional manifestations of the directional aspect to the ground motion were observed near the northern mouth of Tapo Canyon, just south of the Santa Clara River, two miles (3.2 km) west of the Ventura County line. Jerome Treiman (written communication, 1994) reported that ground cracks were widespread within the terrace deposits of Tapo Creek on the Las Brisas orchard property (Figure 1, locality 9). Treiman ascribed the ground failure, which consisted of cracks, scarps, and graben, to lateral spreading or lurching. He did not observe sand boils nor could he otherwise confirm that liquefaction had occurred, although the ranch foreman reported that the land was heavily irrigated prior to the earthquake and the ground was presumably saturated.

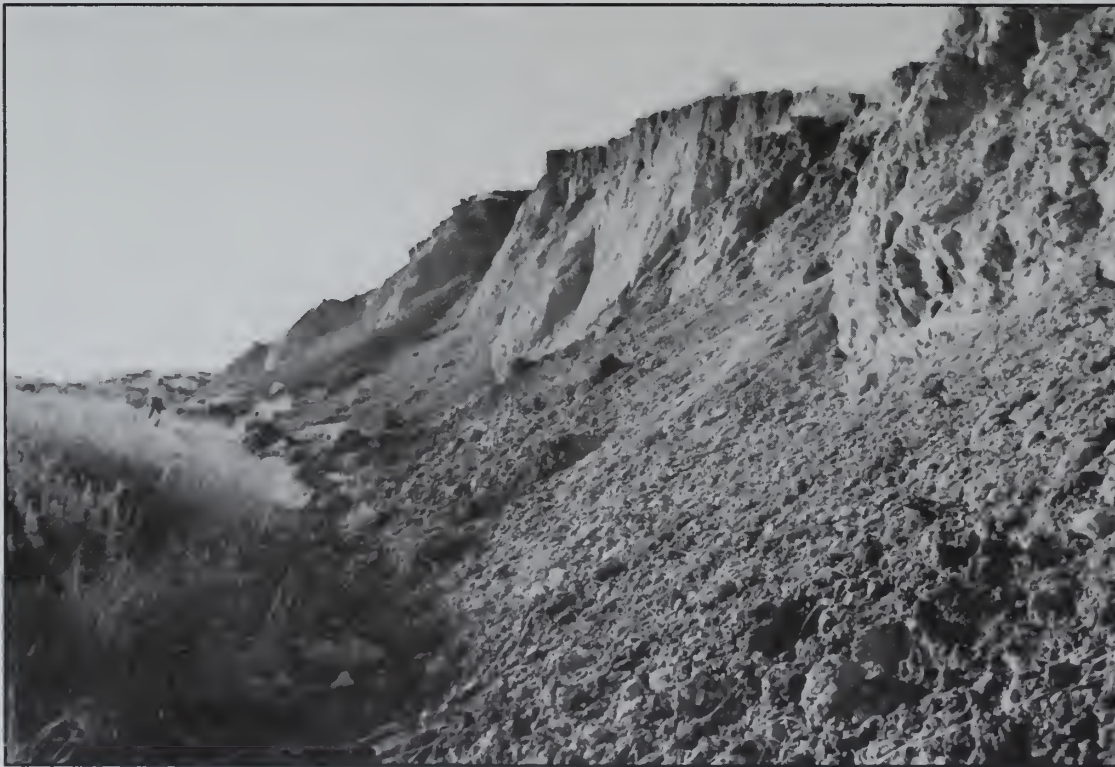
Photo 9. View west along headscarp of immense landslide west of Del Valle Oil Field 1.2 miles (2 km) north of Highway 126 near the Ventura-Los Angeles County line. Note person for scale on left. Photo by S.S. Tan, 3/2/94.

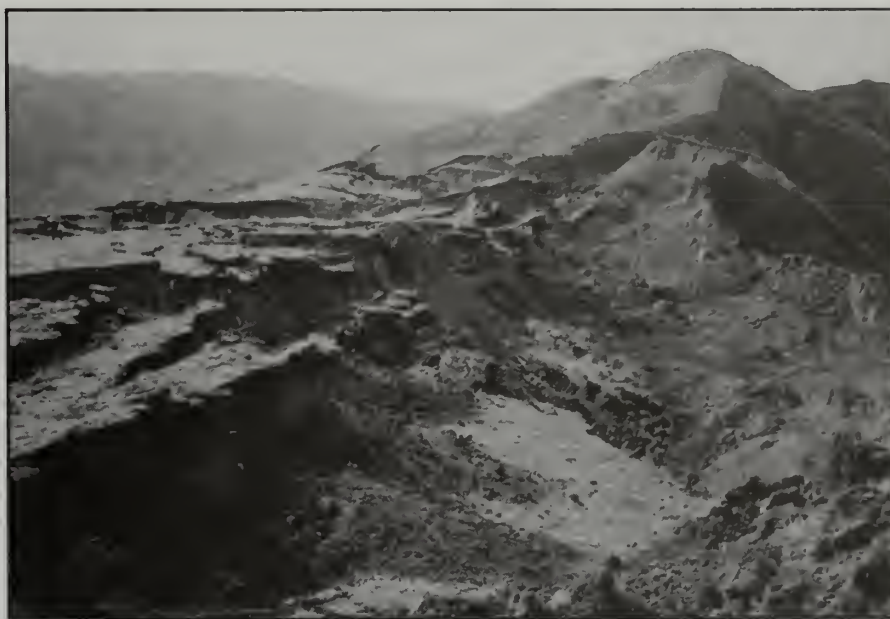
Photo 10. Graben and multiple back-tilted scarps in the western portion of the Del Valle landslide. View toward southwest. Person for scale at left. Photo by A.G. Barrows, 1/31/94.

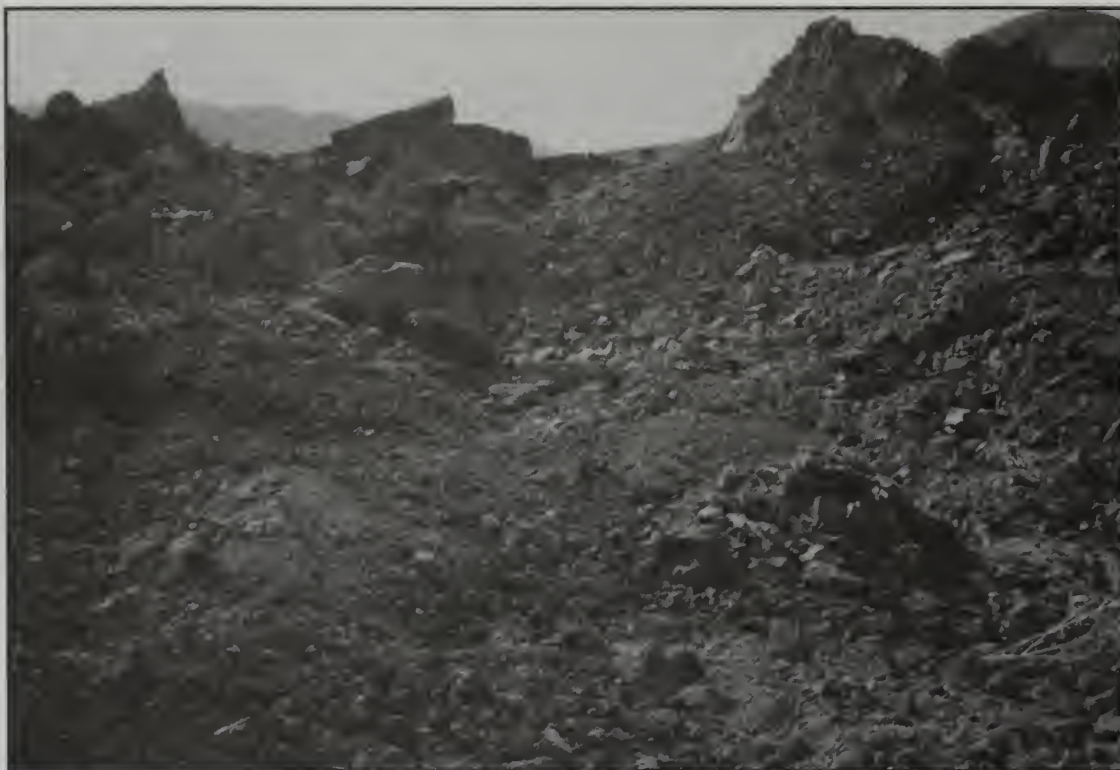
As depicted on geologic maps of the Val Verde area (Winterer and Durham, 1962; Barrows, 1986; Dibblee, 1993), complexes of large landslides are very abundant in terrain underlain by the siltstone and fine-grained sandstone member of the Pliocene marine Pico Formation. Coincidentally, both the Ramona and Del Valle oil fields, which lie along the Los Angeles-Ventura County border north and south of San Martinez Grande Canyon, respectively, are also situated within Pico Formation siltstone units exposed along the axes of large anticlinal folds. The largest landslide triggered by the Northridge earthquake straddles the county line 1.2 miles (2 km) north of Highway 126, south of San Martinez Grande Canyon, and west of the Del Valle oil field (Figure 1, locality 10). This huge rotational landslide was produced by reactivation of a pre-existing massive landslide (triggered by a pre-historic earthquake?) along with substantial enlargement by headward migration toward and, locally, beyond, the top of a ridge on the north. The headscarp is at least 0.5 mile (0.8 km) long and as much as 80 feet (24 m) high (Photo 9). Disrupted and fissured ground covers more than 40 acres. The total volume of mobilized material probably exceeds 5 million cubic yards (3.8 million m³). In the upper portion of the landslide, dramatic graben and back-tilted blocks developed parallel to the headscarp (Photo 10). On the western half of the landslide numerous cracks and fissures developed at right angles to the primary transverse cracks. Within this jumbled terrain, the siltstone and fine-grained sandstone beds of the Pico Formation were literally pulverized (Photo 11) during what must have been extremely violent shaking in the headscarp area.

Photo 11. Fine-grained sandstone of the Pico Formation was thoroughly pulverized by extremely intense shaking along the top of the ridge at the head of the Del Valle landslide just west of the Ventura-Los Angeles County line. Photo by A.G. Barrows, 1/31/94.

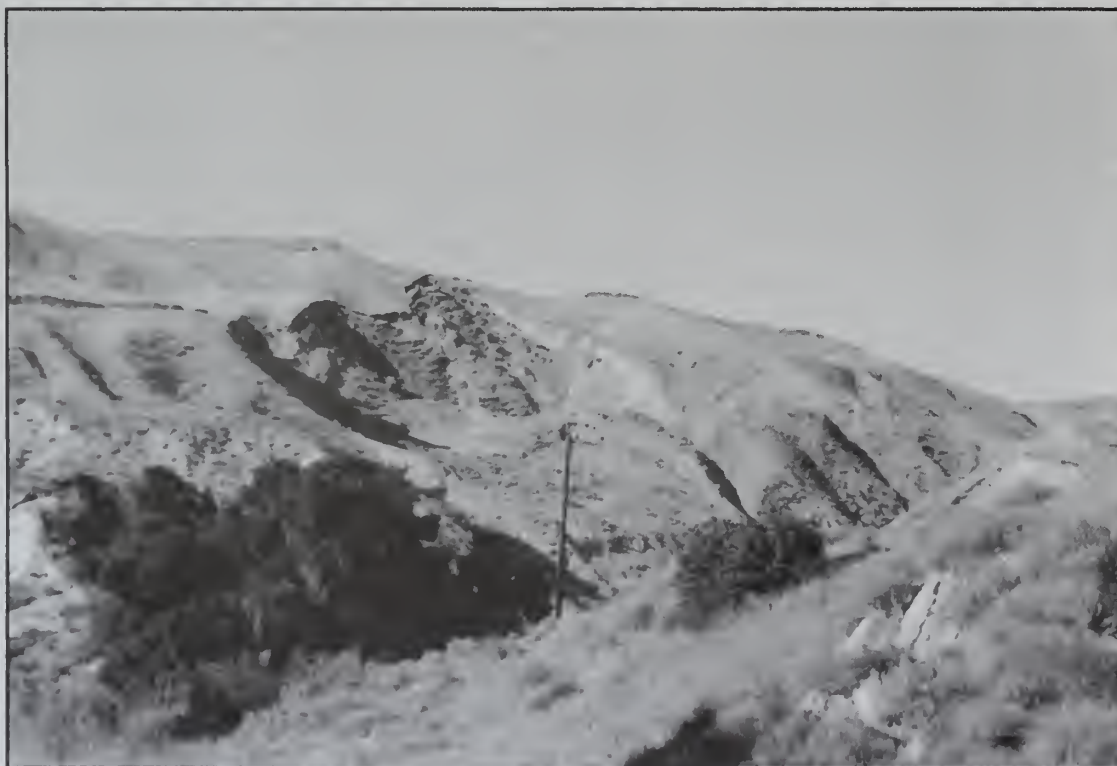
Photo 12. Large slump-type landslide on a dip slope in fine-grained Pico Formation sandstone beds along the ridge north of San Martinez Grande Canyon. Slide damaged oil facilities in the Ramona Oil Field. Photo by S.S. Tan, 3/2/94.

Perhaps a dozen other very large landslides, mostly slumps, developed on south-facing dip slopes in Pico Formation siltstone in the Val Verde and Piru quadrangles. In the Ramona oil field, north of San Martinez Grande Canyon large landslides (Photo 12) damaged oil wells, tanks, and access roads (Figure 1, locality 11). Several large slumps, visible from Highway 126, developed along the ridge top about one mile (1.6 km) north of the highway and two miles west of the Los Angeles County line. The farthest north that a very large landslide was triggered by the earthquake, 22 miles (35 km) from the epicenter, is just west of Loma Verde near the northern boundary of the Val Verde quadrangle (Figure 1, locality 12).

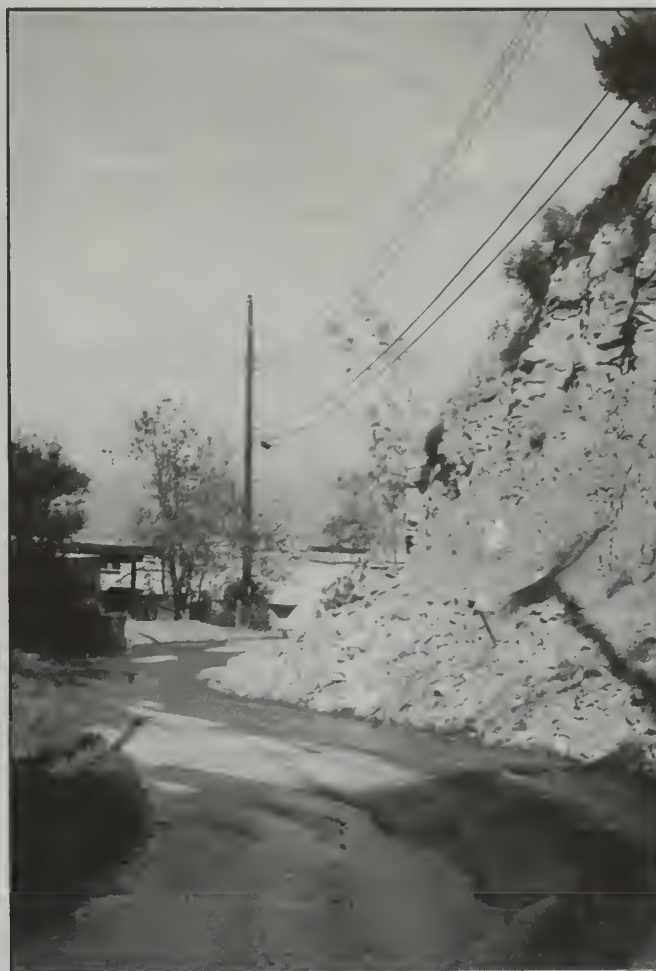
Photo 13. Piles of debris from earthquake-triggered rockfalls from roadcut in north-dipping platy shale and siltstone layers of the Modelo Formation on Oakfield Ridge Drive, Sherman Oaks, in the Santa Monica Mountains. Water on road is from broken water-pipe service connections beneath pavement. Photo by A.G. Barrows, 1/19/94.

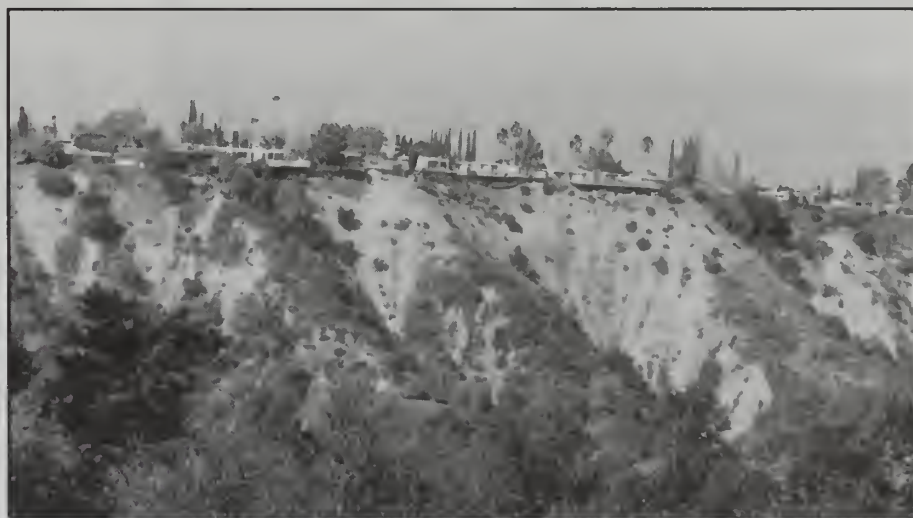
Photo 14. Very shallow soil falls and debris slides on south-facing slopes descending from ridge traversed by Beverly Ridge Drive, Sherman Oaks, Santa Monica Mountains. Photo by S.S. Tan, 1/19/94.

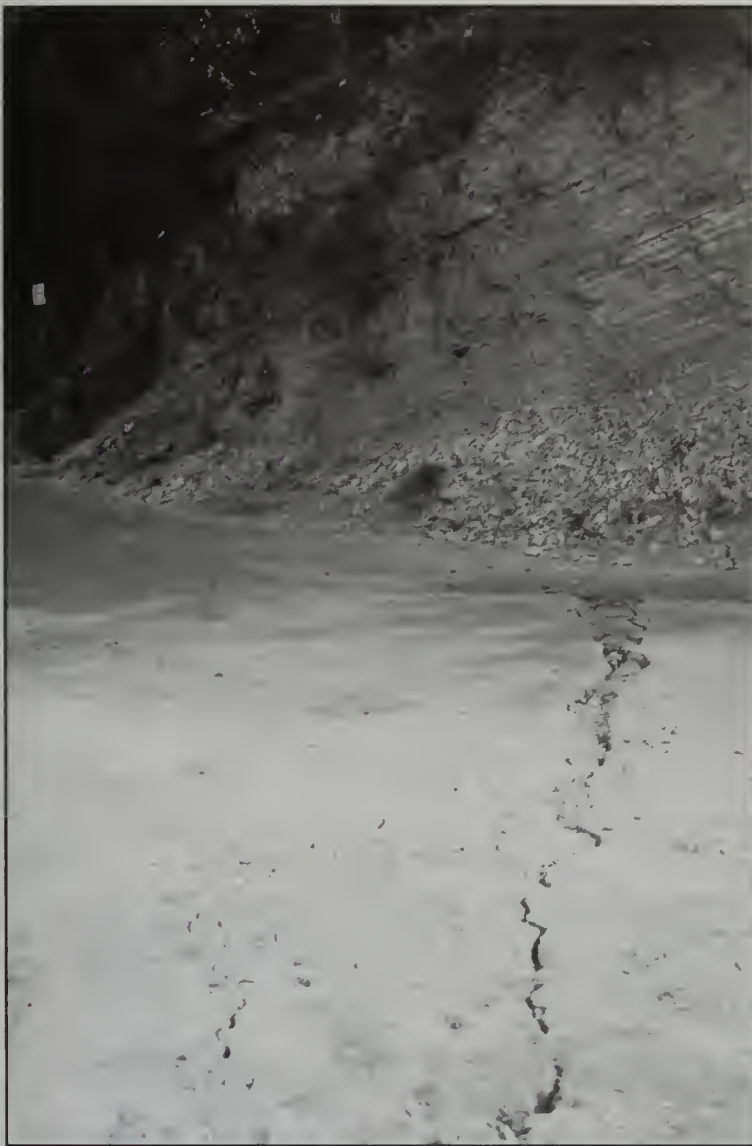
Photo 16. Crack across unpaved portion of Oakfield Ridge Drive, Sherman Oaks, in the Santa Monica Mountains, that opened up along the strike of the platy shale beds exposed in the roadcut. Bedding-plane slippage on a northward-facing dip slope caused the cracking. Photo by S.S. Tan, 1/19/94.

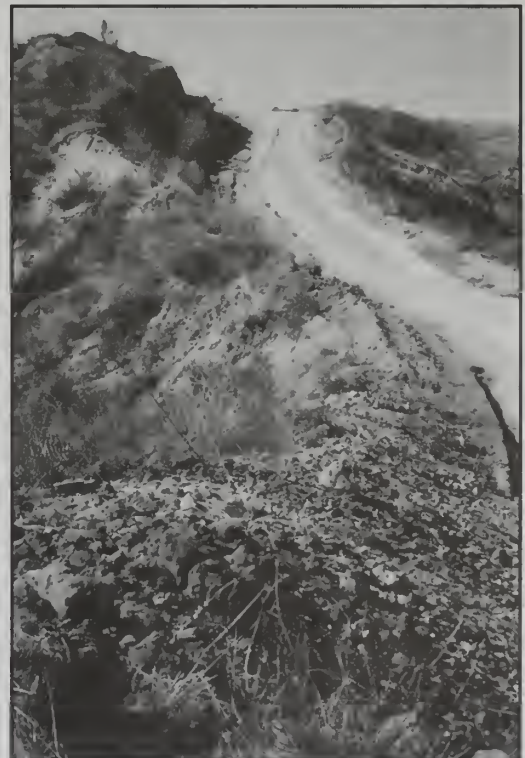
Photo 23. Shattered ridgetop in thin soils on gneissic rock along the crest of Kagel Mountain about one mile (1.6 km) east of Pacoima Dam. Photo by A.G. Barrows, 1/20/94.

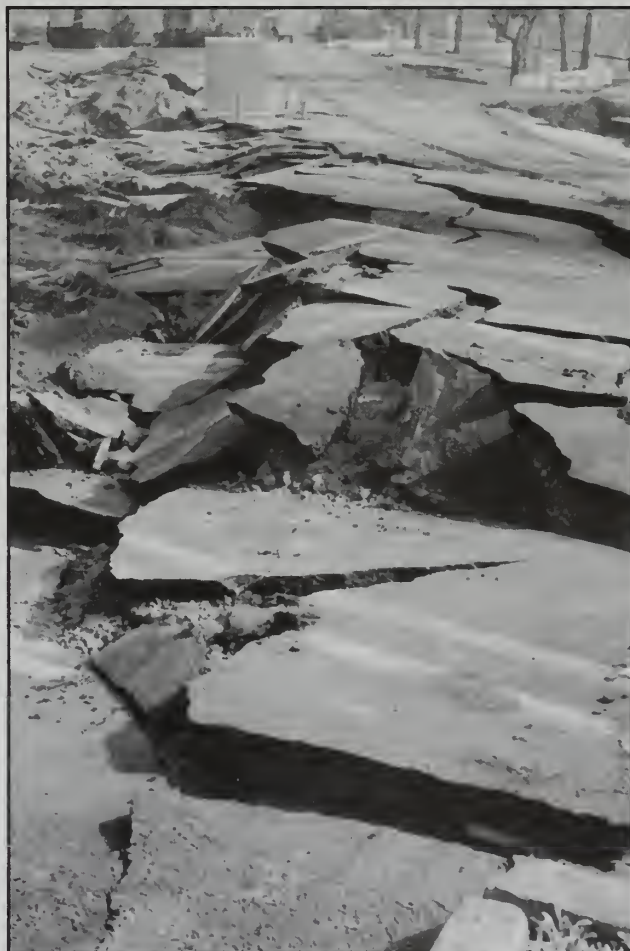
Most of these areas experienced little or no damage except for the places where artificial fill failed by lateral spreading and settlement at King Harbor Marina (Photos 25 and 26) and at the Port of Los Angeles.

Photo 25. Shattered pavement, chaotically disrupted by liquefaction-related lateral spreading of fine-grained sandy fill materials along Mole B, King Harbor Marina, Redondo Beach. Photo by S.S. Tan, 1/20/94.

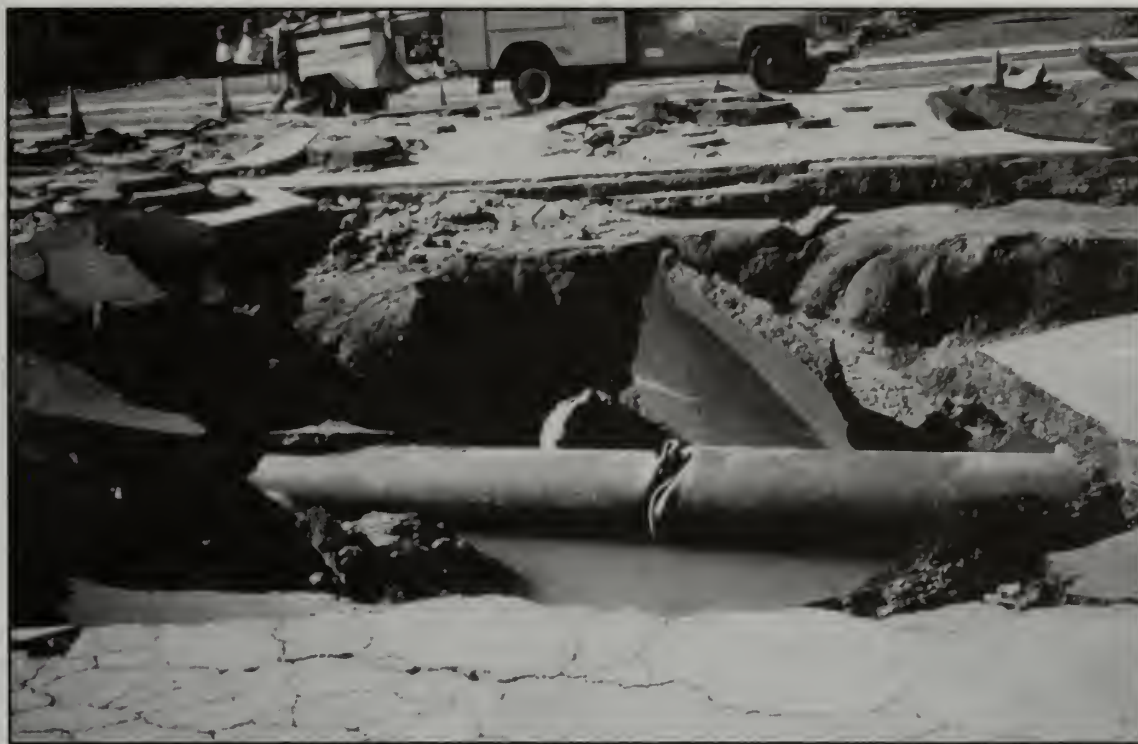
Photo 3. Zone of compression at the toe (south margin) of a lateral spread feature caused this pipeline to telescope at least 25 cm and the adjacent street and sidewalks of Balboa Boulevard to buckle. Locality 3a, Figure 2, about 350 m south of Photo 1.

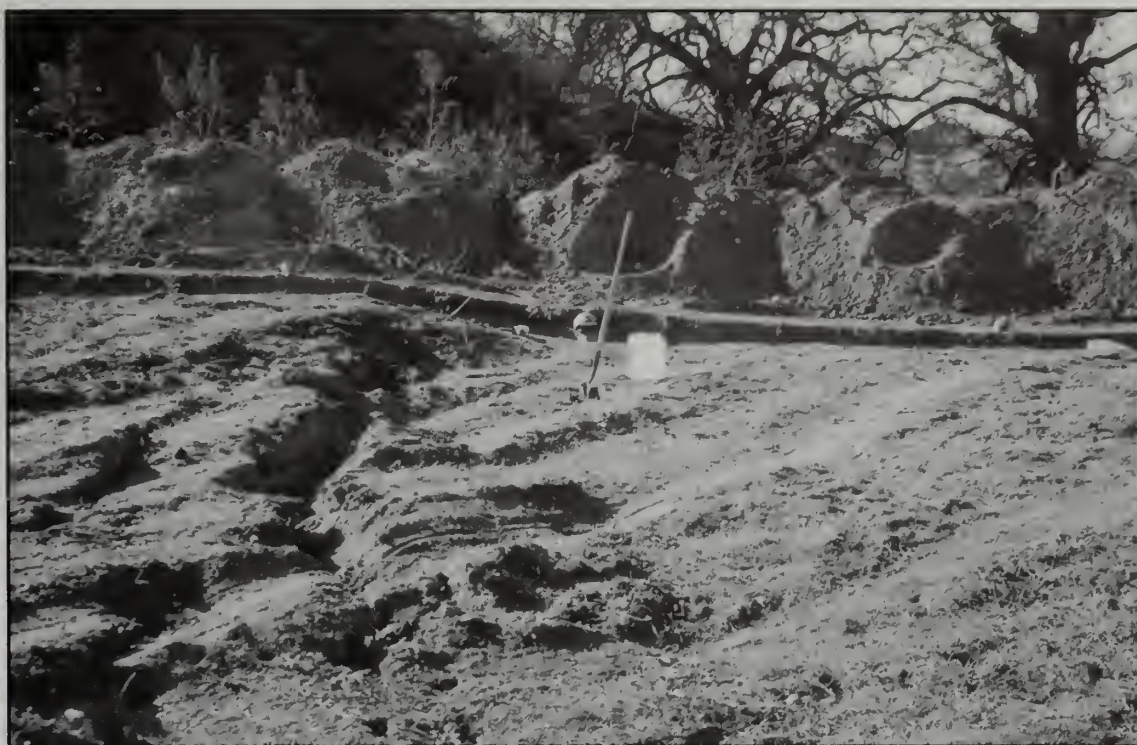
Photo 5. Scarp along south margin of Potrero Canyon shows about 35 cm of vertical displacement; right-stepping cracks suggest component of left-lateral displacement. Ruptures are due to settlement and westward lateral spreading of young valley fill. Nearby sand boils (not shown) indicate that liquefaction occurred (Locality 14, Figure 1).

suggested this might be primary faulting. These extensional cracks occurred in Holocene alluvium, had up to 35 cm of vertical displacement (valley side down), and locally had a right-stepping pattern (Photo 5). Extensional cracks on the north side of the valley showed up to 45 cm of vertical displacement (valley-side down) and a left-stepping pattern. Evidence from subsequent investigations suggests that the alluvium of Potrero Canyon settled significantly and laterally spread westward down-valley. Other extensional cracks in re-entrant drainages are consistent with this conclusion. The presence of sand boils in two places adjacent to the extensional cracks indicate liquefaction at a shallow depth.

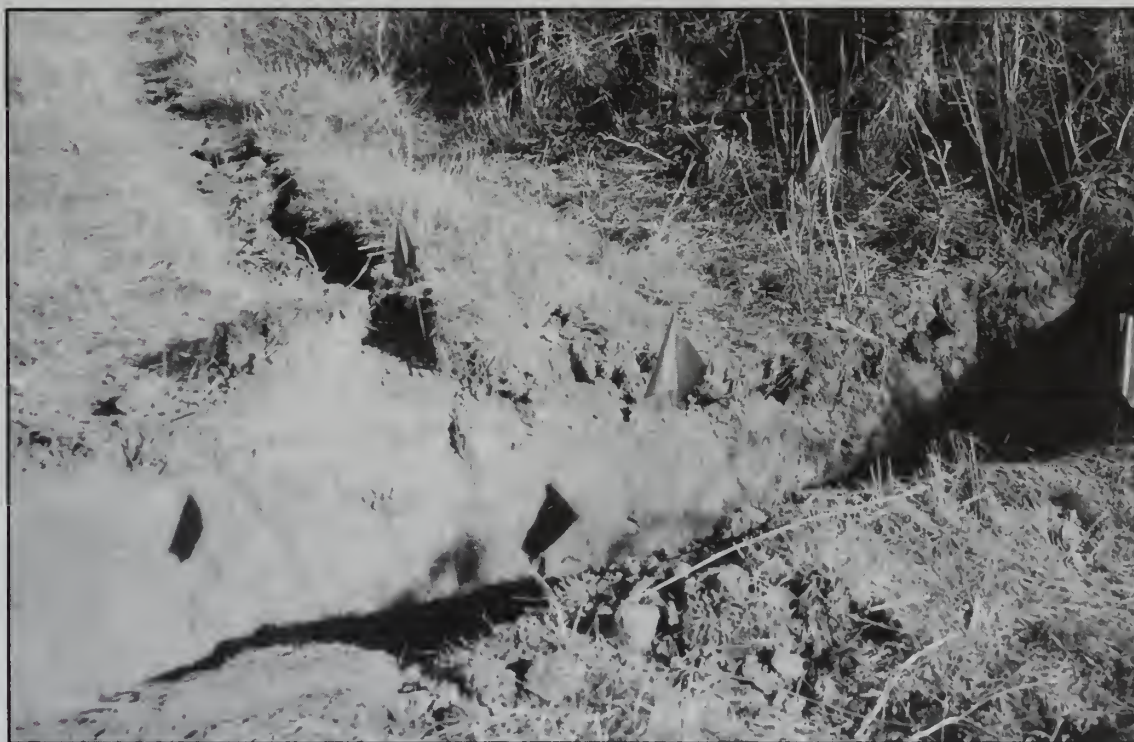
Photo 6. Moletrack in soil at base of bedrock slope initially suggested thrust faulting at south margin of Potrero Canyon, but trench reveals that soil and root-mat were merely uncoupled by shaking. No faults were identified in the trench (Locality 14, Figure 1)

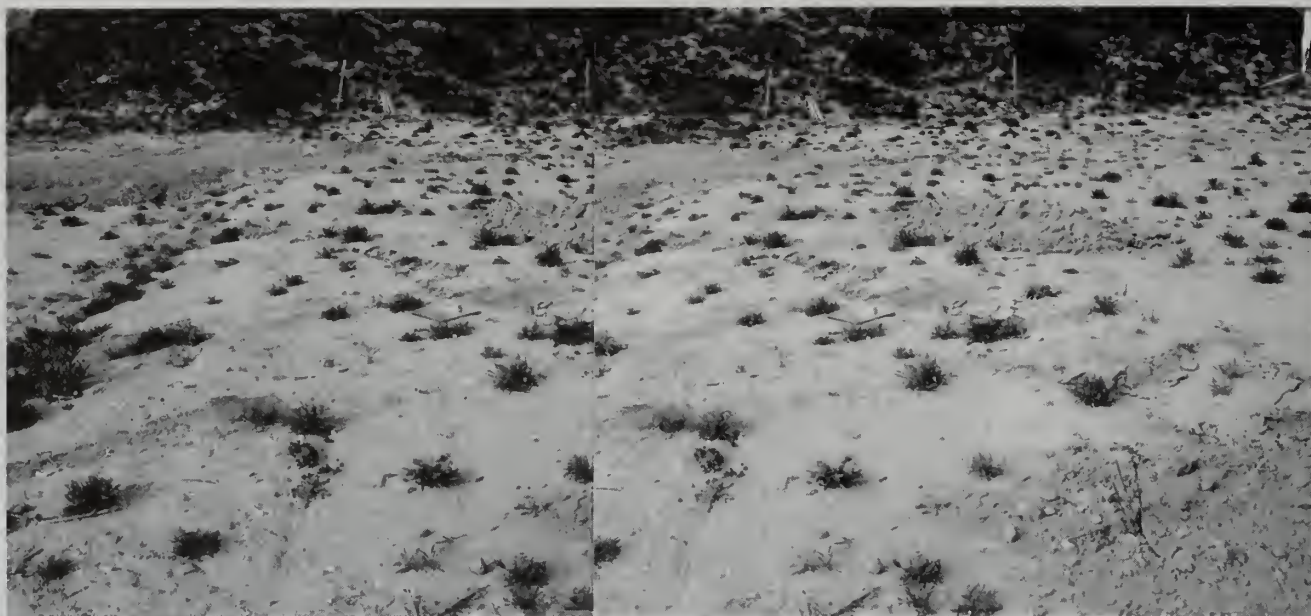
Photo 1. Stereo-pair shows northerly view of 8 cm scarp along thrust fault. Photo by J. Treiman.

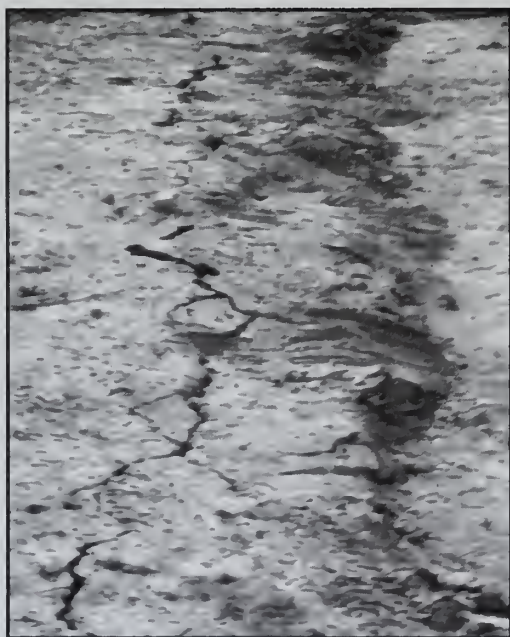
Photo 2. View southeast along the main rupture zone showing southwest-facing scarp. Note the tensional fracture which was typical along the thrust front. Photo by D. Sherman

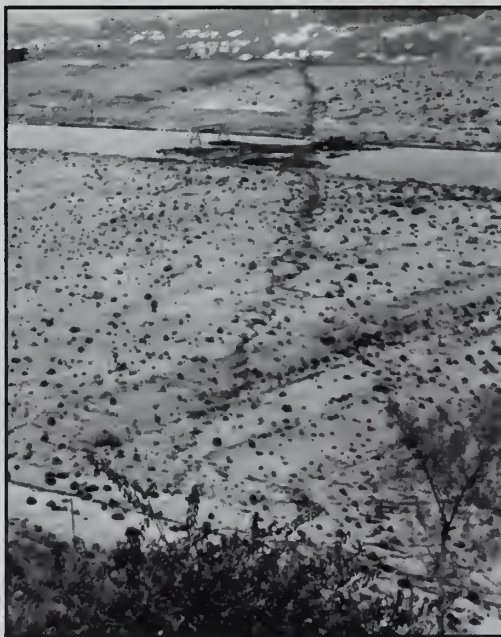
The most continuous rupture (western zone) extended for about 250 m with a general trend of N40°W (photo 3). A post-earthquake survey for the landowner has documented at least 0.4-0.5 feet (12-15 cm) of vertical displacement (northeast side up) along the main rupture. [19 cm vertical displacement was measured by the author based on visual sighting across the scarp with a tape and is slightly at odds with the post-earthquake survey data. The visual measurement may have been skewed by the original slope of the graded pad, or may reflect ground warping not evident in the survey data]. Trenches across the rupture document a strongly developed bedding-plane shear zone dipping 50°-56°NE and associated with a thick (up to 0.5 m) claystone unit. Smaller parallel ruptures lay approximately 40-80 m to the northeast. One short 2 cm-high scarplet was also observed about 50 m to the west.

Photo 3. View southeast along the most prominent rupture zone. Photo by D. Sherman.

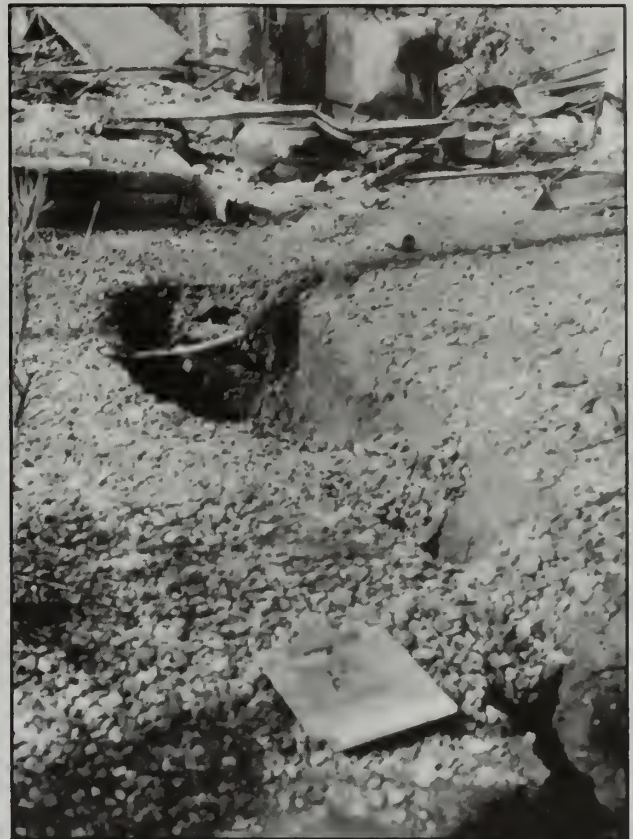
Photo 2. Close up view (to northwest) of large ground crack where it disappears beneath remnants of burnt house at 11661 Balboa Blvd. (Photo 1). Measurements from a trench at this site document 22 cm of southeast-side-down vertical separation at the ground surface. The crack was widened considerably by caving from surface flooding following rupture of nearby water mains. Photo by S. Hecker.

east-directed ground movement during the earthquake. The most prominent subzone of tension cracks locally reaches a width of 50 m and extends westward from Bull Creek to approximately Amestoy Ave. (Figure 3). This subzone crosses Balboa Blvd. (Photo 1) where the pipelines failed in tension. Less well defined subzones of tension cracks are observed in the area bounded by McClennan Ave., Rubio Ave., Armstead St., and Halsey St. (Figure 3). Individual ground cracks in these subzones are typically several meters long and rarely extend for more than a few tens of meters. The cracks trend mostly northeast to east-southeast and display a component of lateral slip that varies depending on the specific angular relation between their orientation and the ground-movement direction. Azimuths of horizontal vectors measured across individual ground cracks range from 130° to 170° (Hecker and others, 1995). This direction of movement is roughly parallel to the area's topographic gradient (Figure 2). Vertical displacements, where present, are generally down to the southeast. Amounts of vertical and horizontal displacement are rarely more than a few cm per crack, although some cracks display as much as 25 cm of vertical separation (Photo 2). Unlike the rest of the

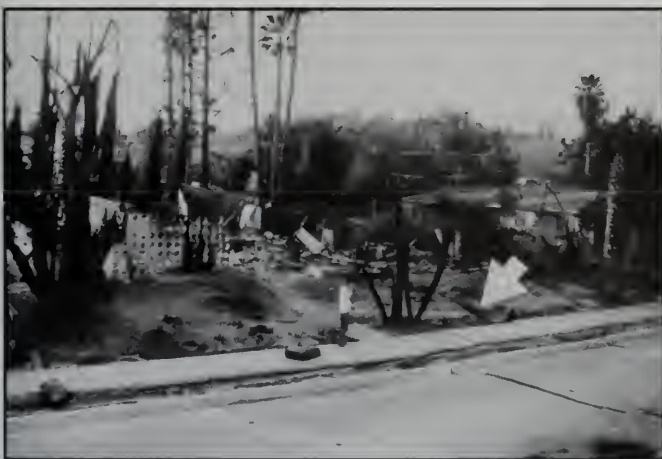
Photo 1. View to northwest of principal zone of tension cracks and one of five houses destroyed by fire on Balboa Blvd. (west of locality 1a, Figure 3). Tensile failure of gas lines beneath the street (to the right of view) led to the fire. Note large ground crack (arrow; see Photo 2), with southeast-side-down vertical separation, subsequently exposed in a trench excavated for this study. Photo by M.J. Rymer.

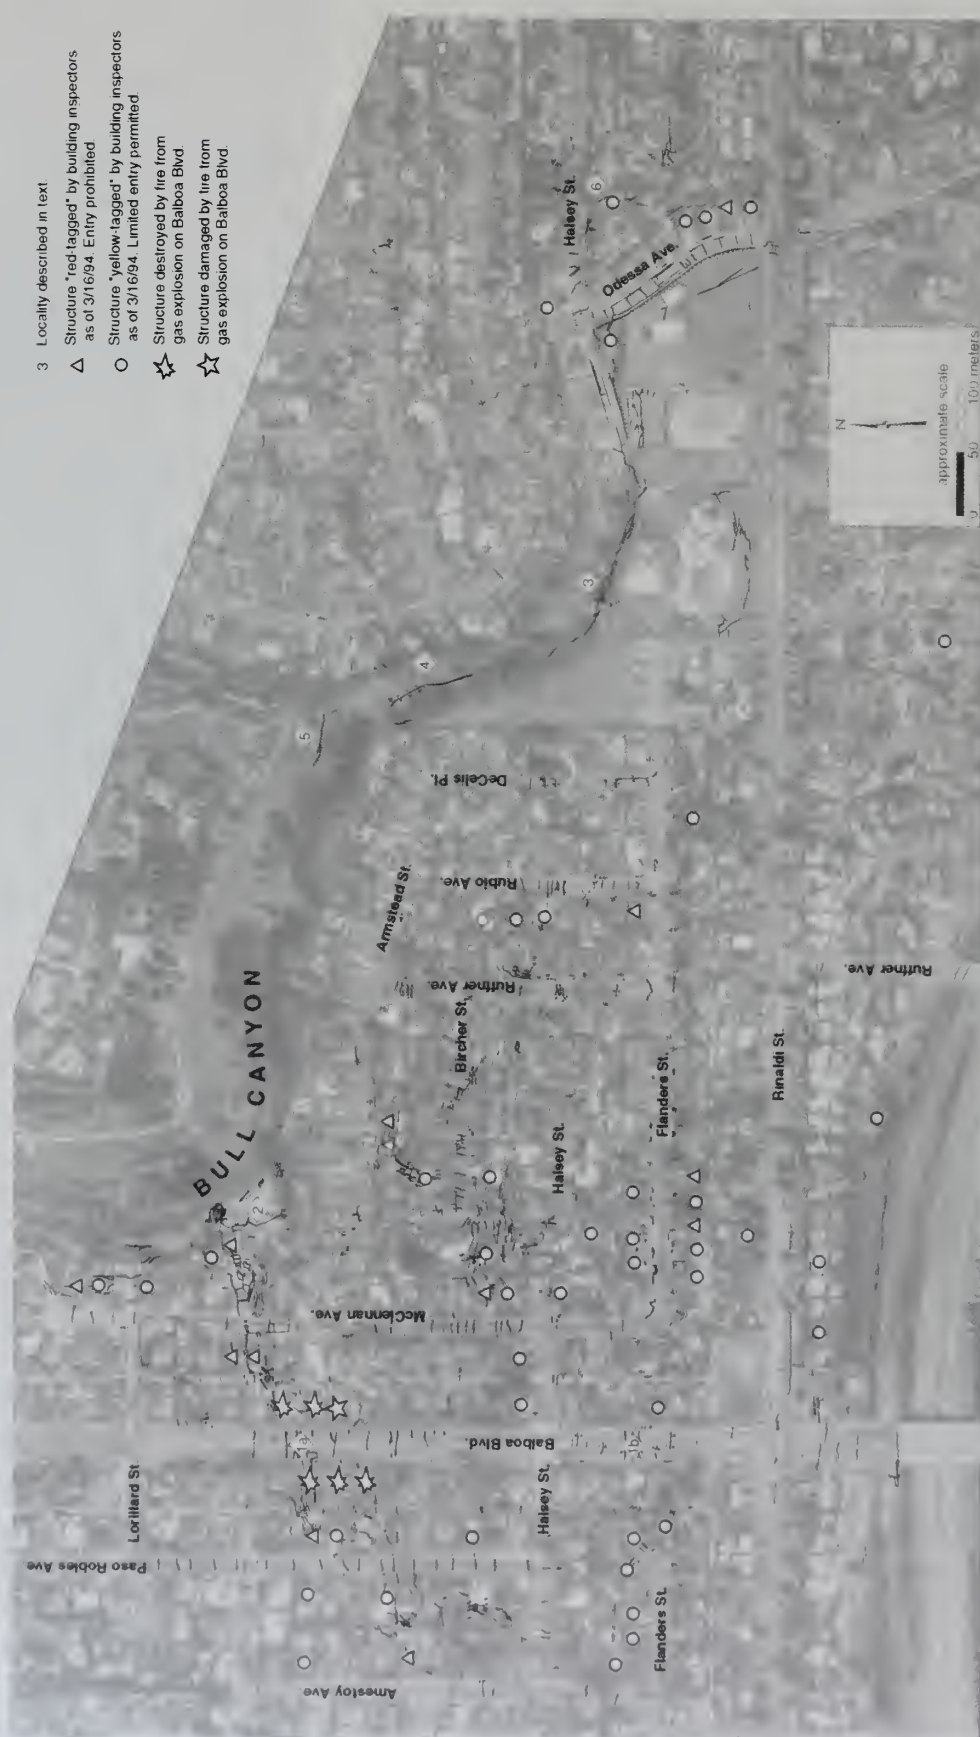
Figure 3. Aerial photograph of the Bull Canyon area taken on the day of the earthquake, showing locations of cracks (dark lines) relative to cultural features and to damaged (tagged) structures (as reported to us by California Office of Emergency Services on 3/16/1994). Cracks from Hecker and others (1995); photo base courtesy of I. K. Curtis Services, Inc.

ground deformation west of Bull Canyon, tension cracks adjacent to Bull Creek indicate east- to northeast-directed movement that is normal to the stream cut and probably is the result of incipient slope failure toward the channel (Figure 3, locality 2).

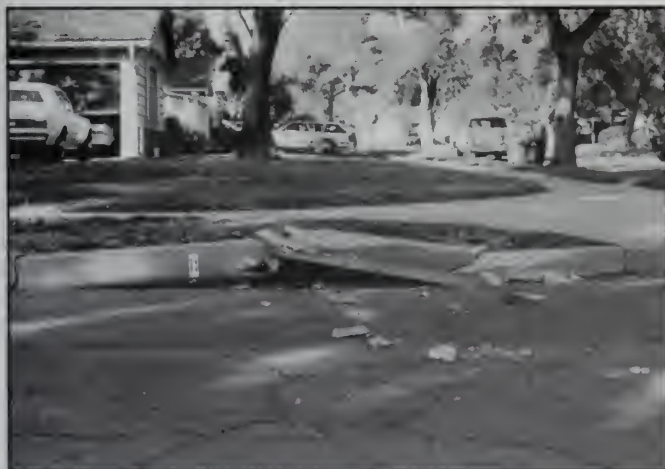
buckled pavement; Photo 3) within the zones of tension cracks, and points to the difficulty inherent in interpreting kinematic data from pavement breaks. Because of these complications, we measured crack-specific displacement vectors only on cracks in natural ground.

Photo 3. Spalled and thrust-shortened curb at northwest corner of Halsey St. and Ruffner Ave. This type of feature is common in the zone of compression near Flanders St. Photo by M.J. Rymer.
